Nordic Hydrological Conference 2018

“How blue-green solutions saved
the world heritage site bryggen”

Bryggen World heritage site

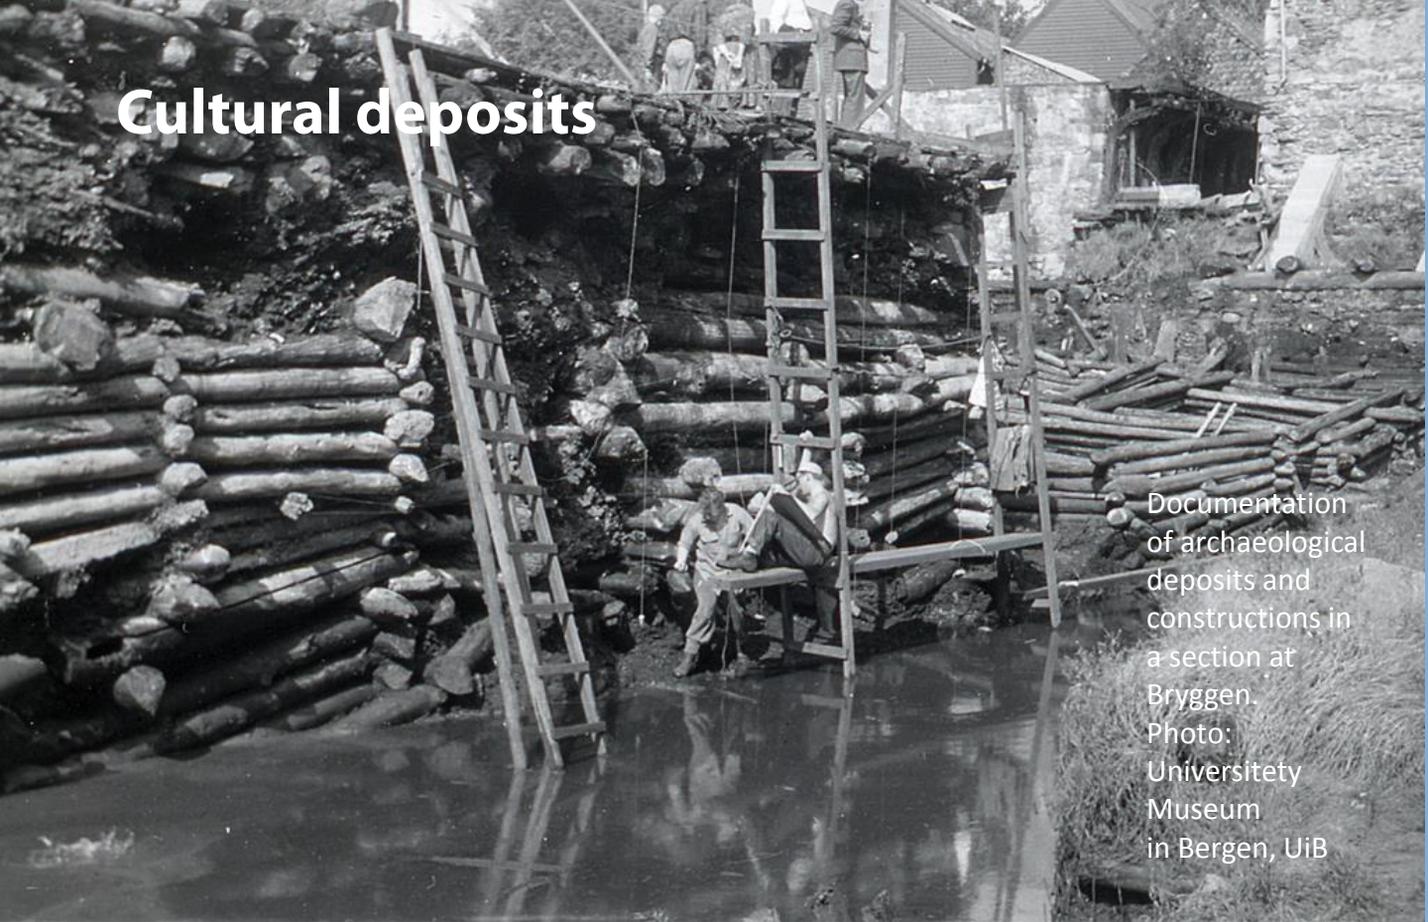
Documentation of archaeological deposits and constructions in a section at Bryggen.
Photo: University Museum in Bergen, UiB

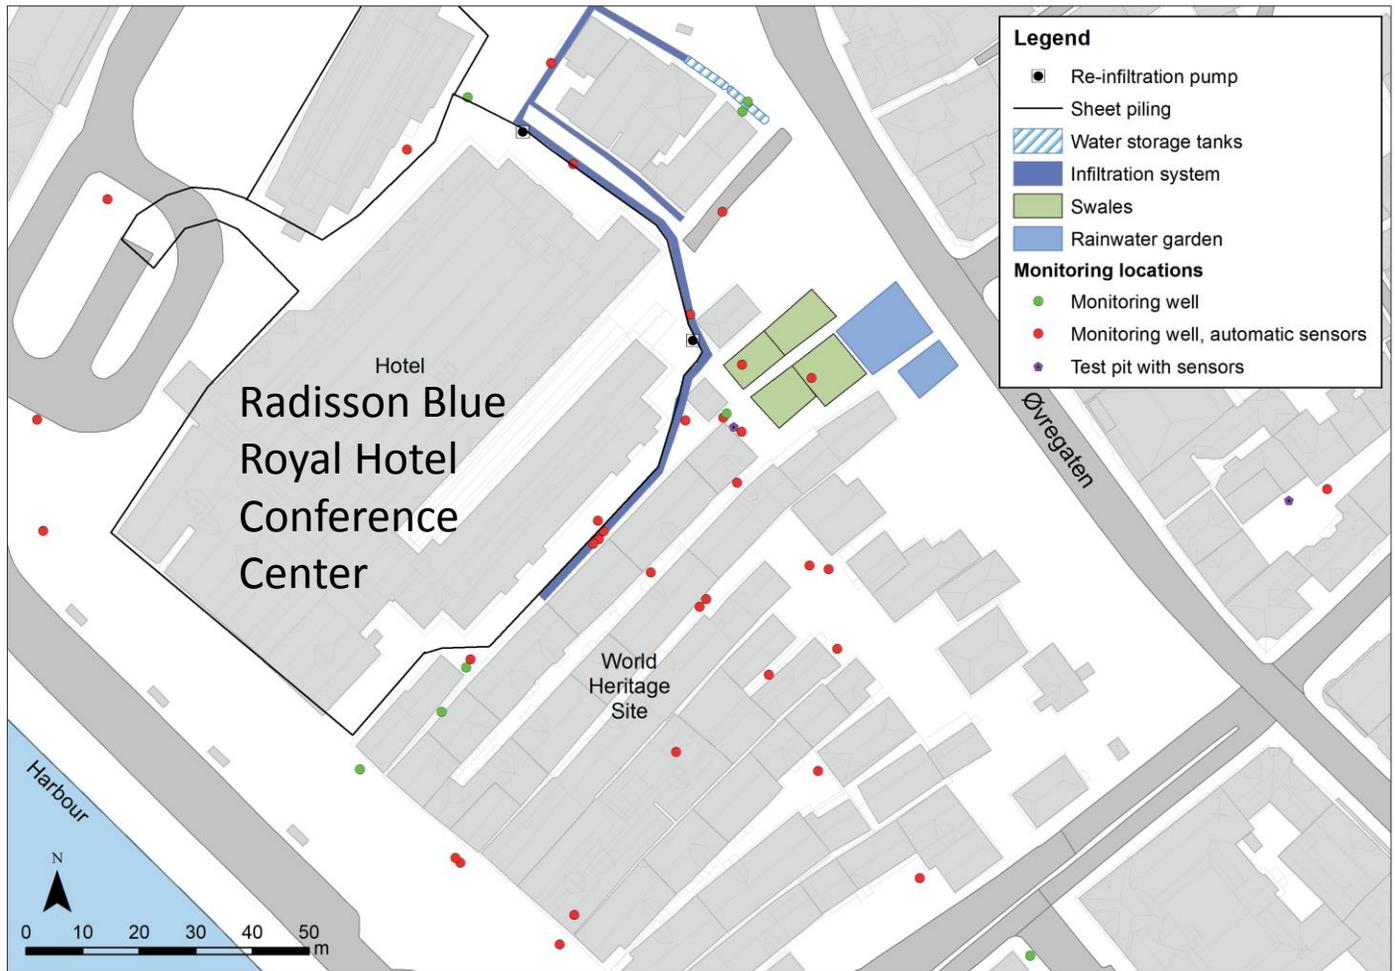
Overview map of mitigation measures carried out by the Groundwater Project, including locations of monitoring wells for measurement of groundwater level, temperature and sampling. Map: Anna Seither, Geological Survey of Norway.

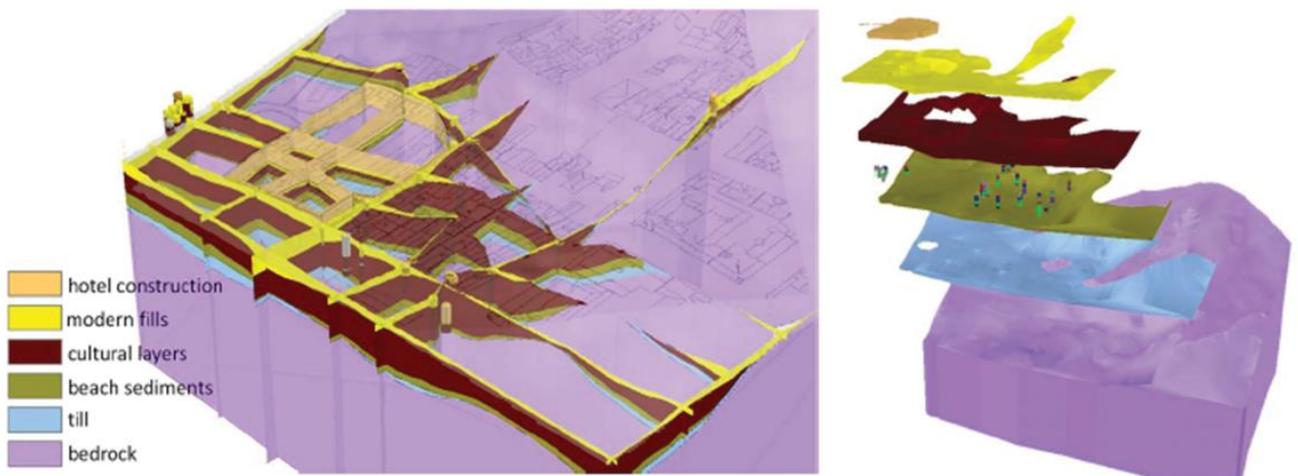
Modell of layers in the subsurface below Bryggen. The cultural layers, consisting mostly of organic material from human waste, can be more than 10 meter thick. Underneath are natural sediments beposited by the fjord and glacier, on top of bedrock. The walls of the modern hotel, sheet pile wall, is marked with orange in the modell (Source: De Beer, 2015).

Cultural deposits are the remnants of human activity over time. They are formed near human settlements, by the accumulation of waste materials and the remains of old building structures. Bryggen is built on top of such deposits – on refuse and the remnants of medieval buildings. In several places, the deposits beneath Bryggen are over 10 meters thick, and represent an invaluable, non-replenishable and endangered historical archive. Until the mid-20th century, the preservation conditions at Bryggen were very good, but until recently, the conditions were growing considerably worse for every passing year. As much as 30 cubic metres of deposits were lost every year.

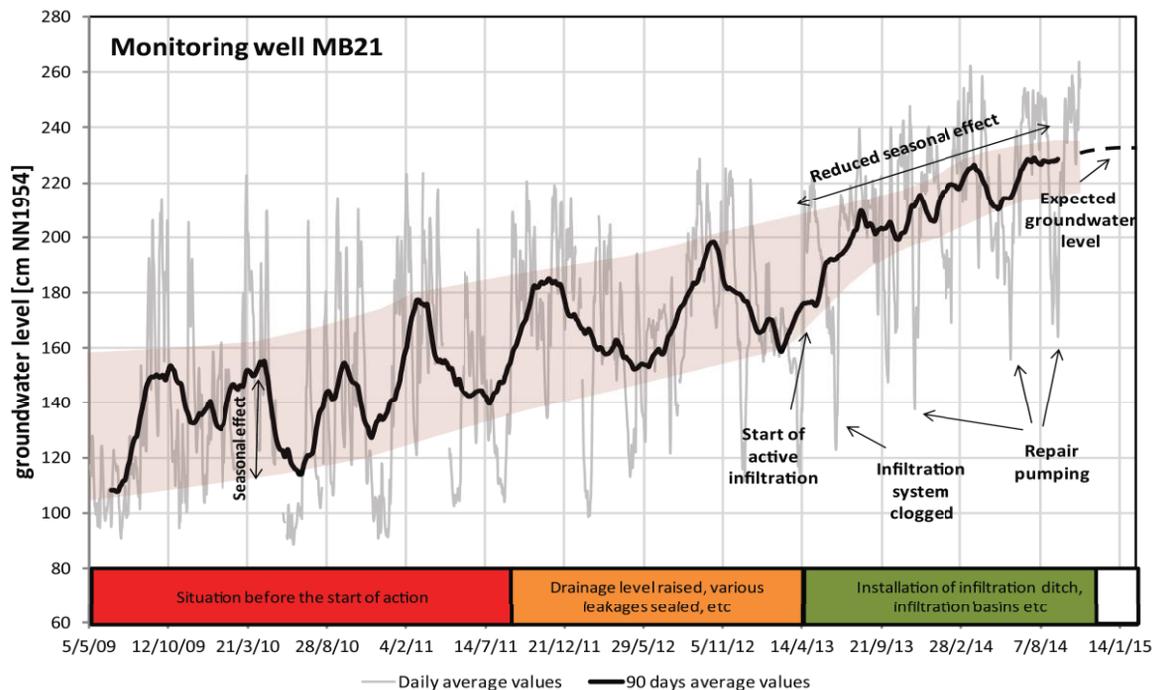
Groundwater level in monitoring well MB 21. The grey line shows daily variations of the groundwater level. The black curve gives a simplified impression of the groundwater level, by showing average values over three-month intervals. Graph: Anna Seither, Geological Survey of Norway

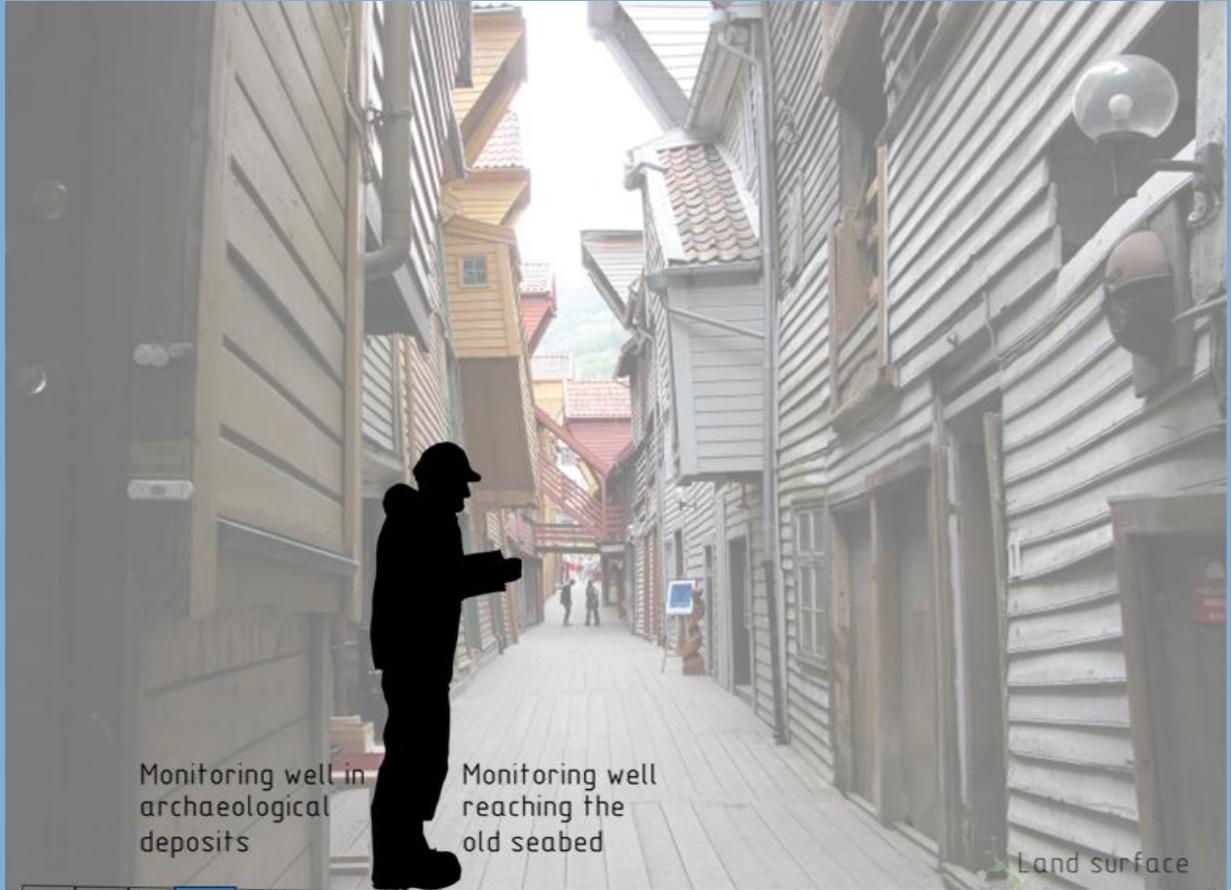
Monitoring well in archaeological deposits

Monitoring well reaching the old seabed

Land surface

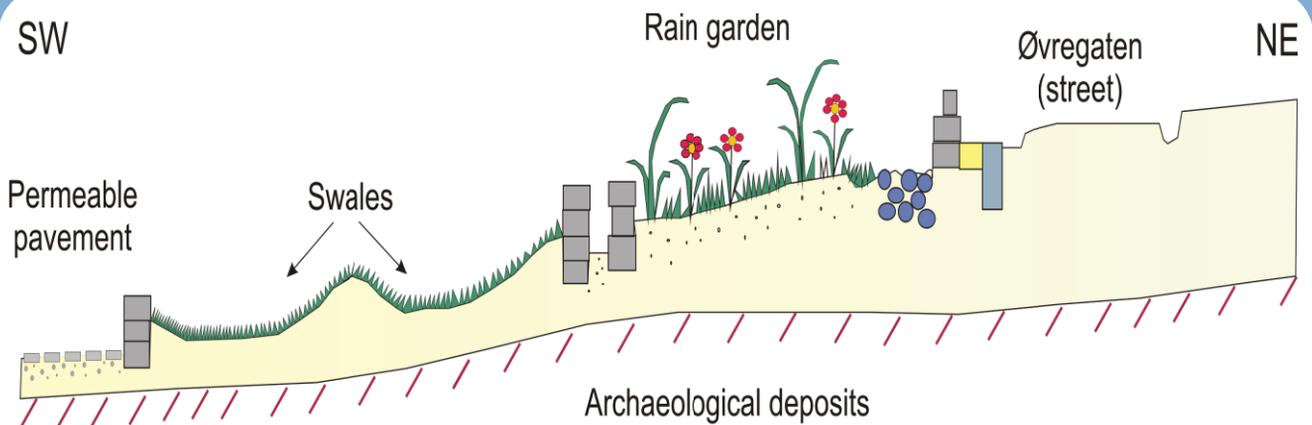
Section of the sustainable water management "treatment train", with rainwater garden, swales and permeable pavement. Drawing: Johannes de Beer, Geological Survey of Norway.

Mitigation measures consist of a “treatment train” made up by rainwater gardens, green swales, permeable pavement and a subsurface infiltration/transport system with storage facility and re-infiltration of groundwater.
